Report NVL-77-0270 ✓

Searchlight Sets  
AN/VSS-4(XE-4)

Final Report for Period 26 October 1976-9 February 1977

Night Vision Laboratory  
U.S. Army Electronics Command  
Fort Belvoir, Virginia 22060

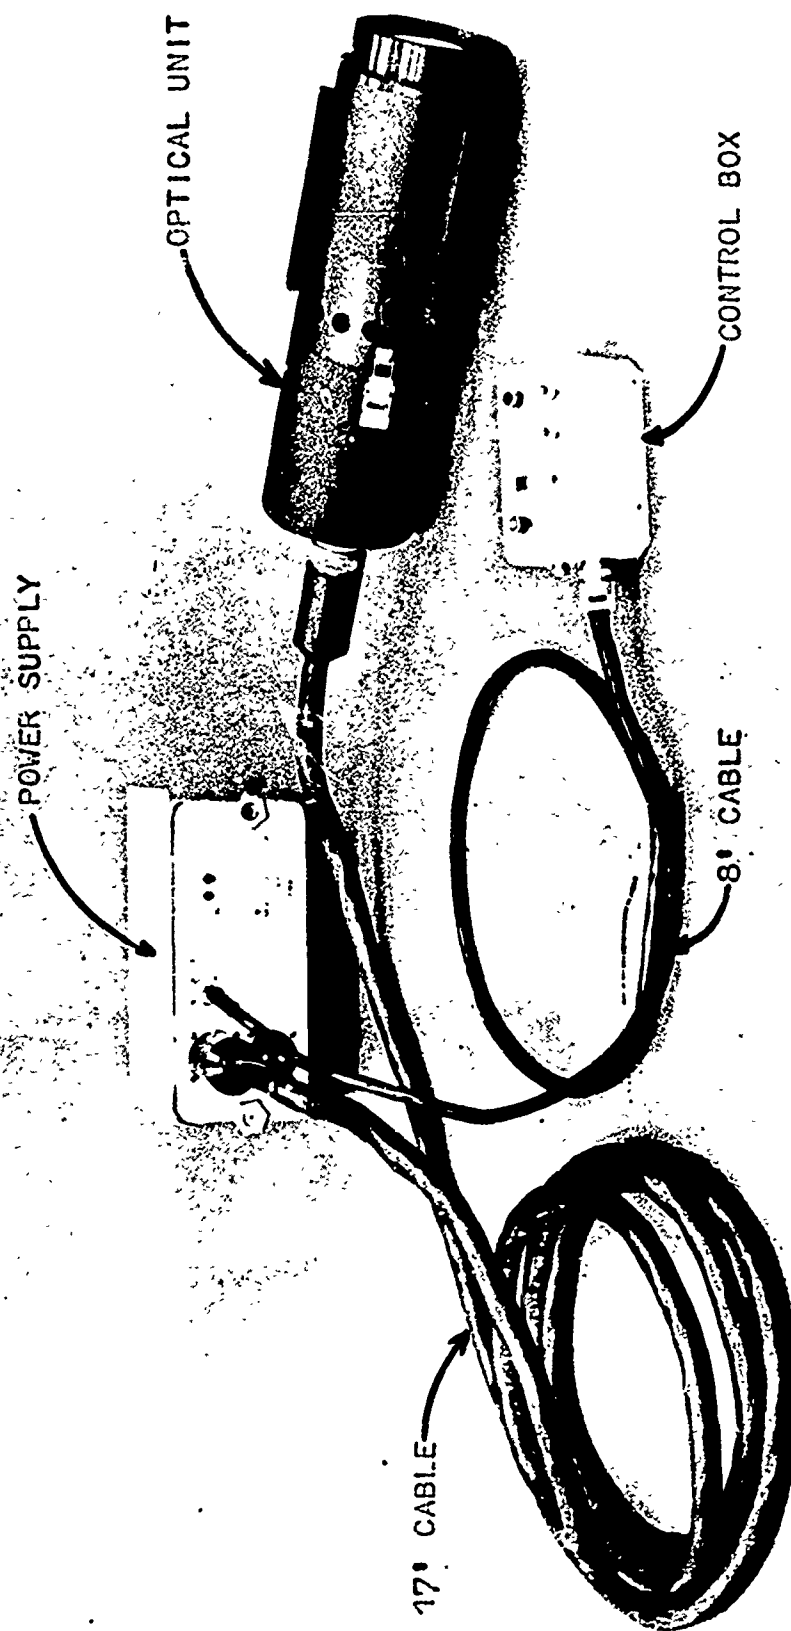
FIGURE 1: EIHAC SEARCHLIGHT SET AN/VSS-4(XE-4)

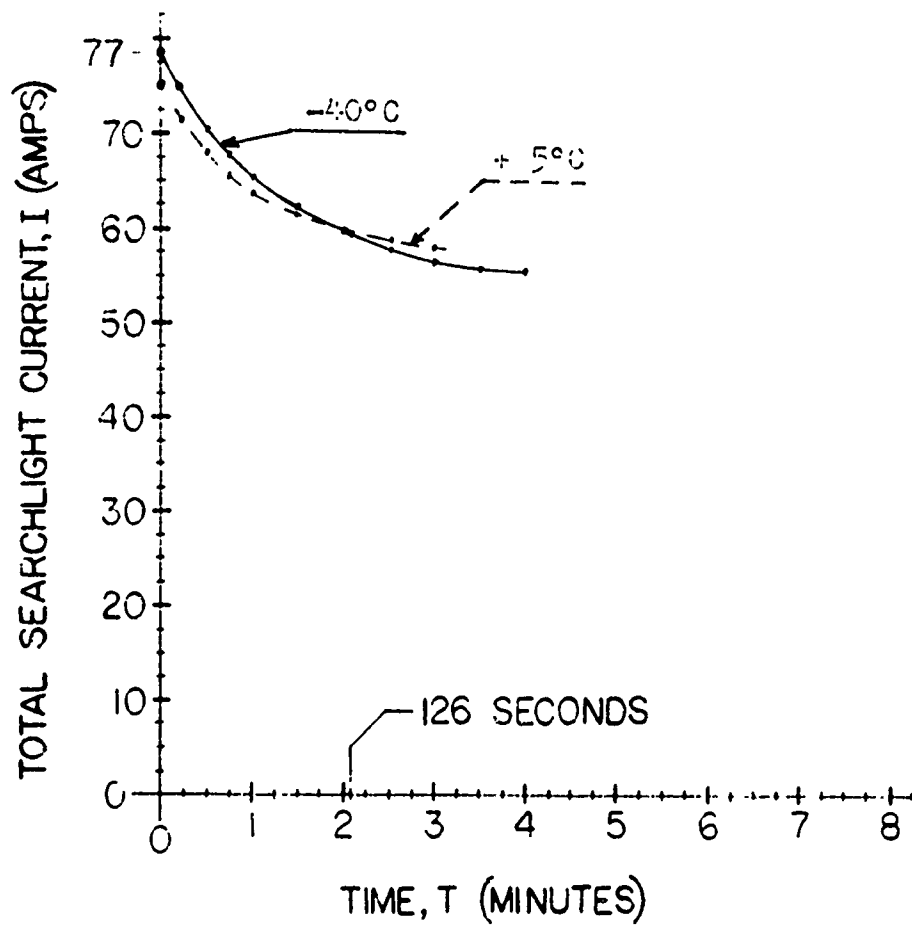
IGNITION AND WARMUP CURRENT FOR 28 VDC OPERATION  
FIGURE 2

The searchlight's input current exceeded 60 amps for the first two minutes of operation at 28VDC (as was noted in Figure 2). All systems functioned properly at 28 and 24 VDC except for the initial opening of the I.R. filter at 24 VDC. The searchlight was examined and the I.R. filter activating solenoid was found to have had an incorrect spring adjustment. This was corrected. The filter then activated as low as 20 VDC.

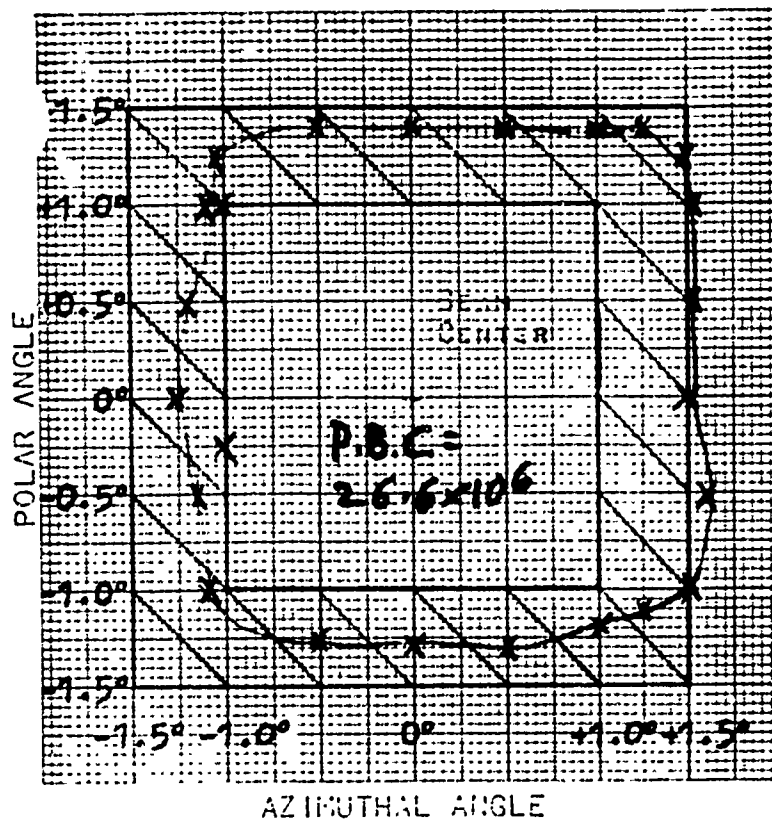
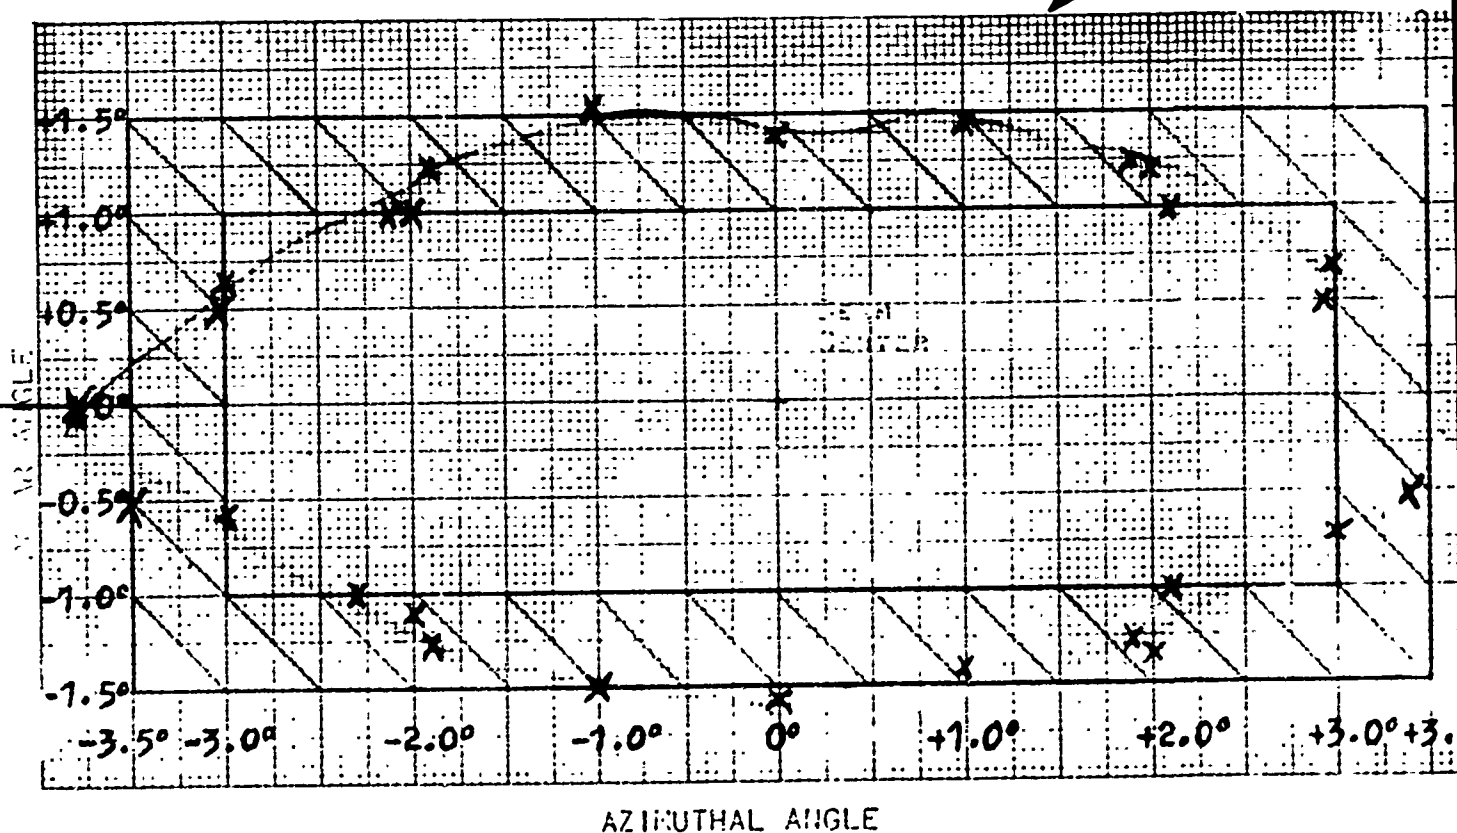
FIGURE 3

ARC LAMP A7E172

ACCEPTABLE ZONES FOR EDGE  
OF BEAM PATTERN FOR COMPACT  
BEAM MODE AND SPREAD BEAM MODE  
(LOCUS OF POINTS AT 2% OF PEAK  
BEAM INTENSITY SHALL FALL WITHIN  
CROSS-HATCHED AREA)

SPREAD BEAM MODE

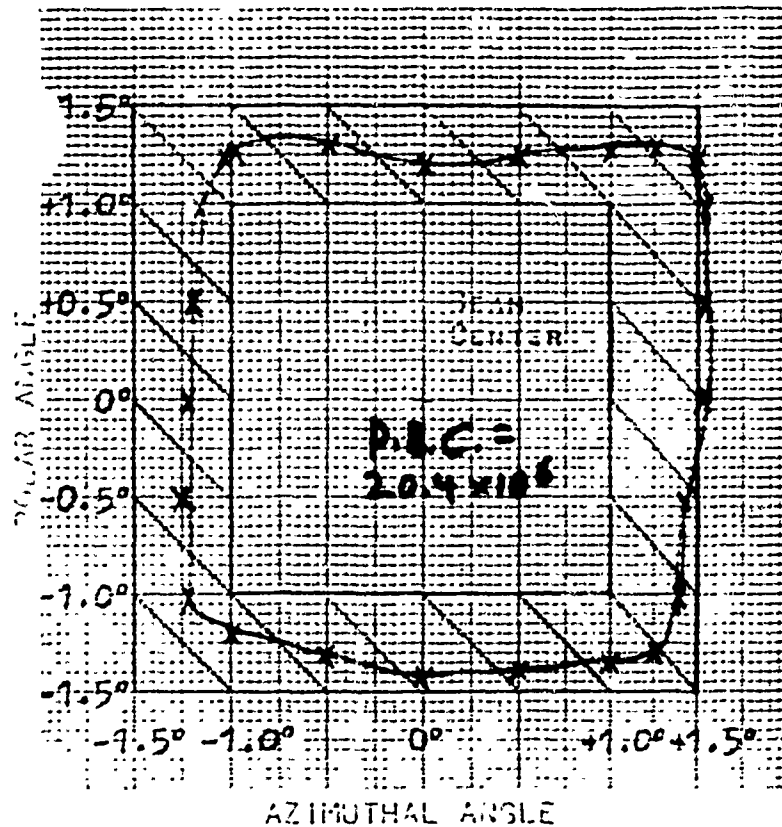
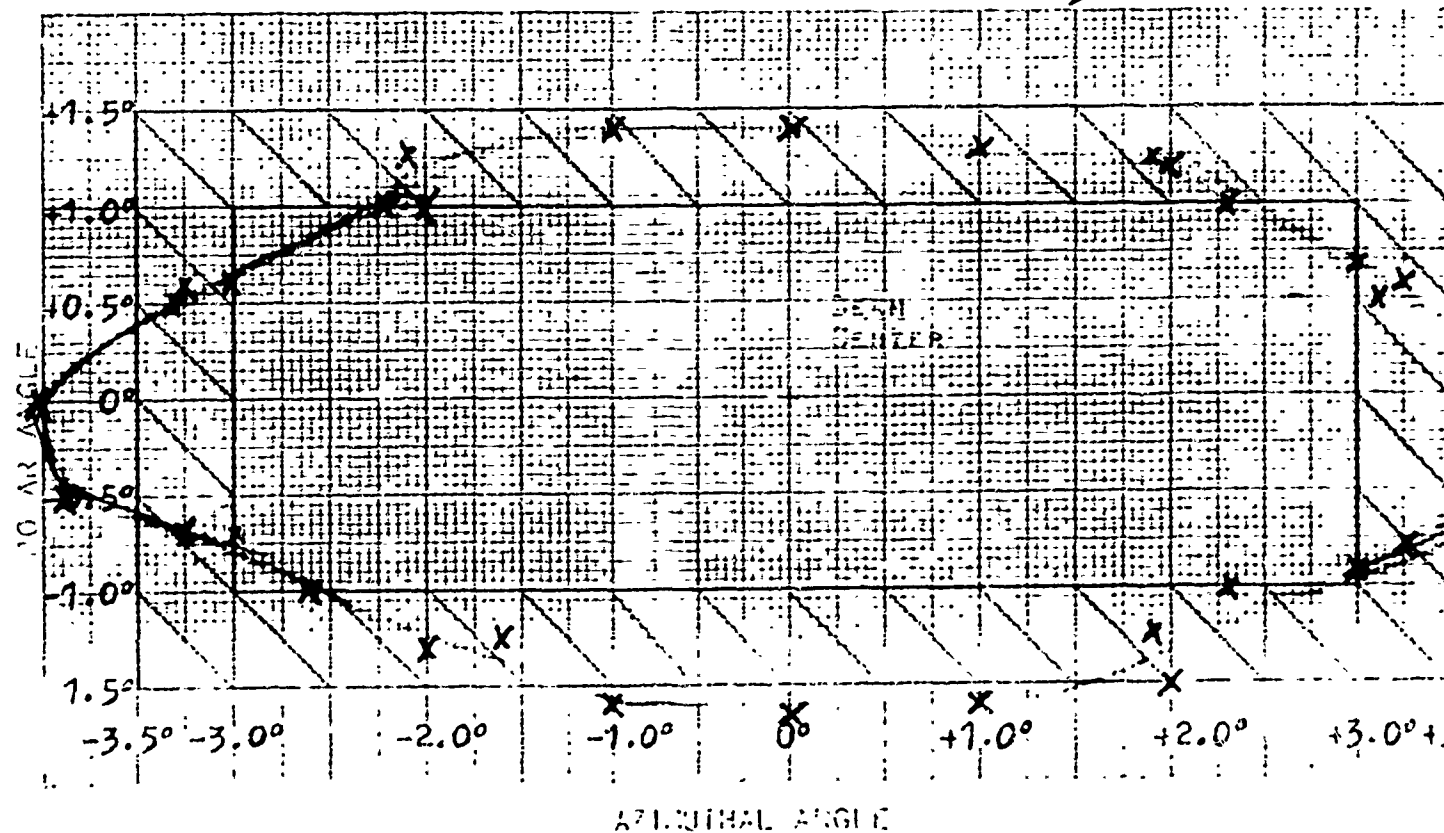
FIGURE 4

# ARC LAMP A7E172

ACCEPTABLE ZONE FOR EDGE  
OF BEAM PATTERN FOR COMPACT  
BEAM MODE AND SPREAD BEAM MODE  
(LOCUS OF POINTS AT 2% OF BEAM  
INTENSITY SHALL FALL WITHIN  
CROSS-HATCHED AREA)

COMPACT BEAM MODE

SPREAD BEAM MODE

Arc lamp A7E172 survived all the environmental tests except for intermittent sticking of the stinger to the lamp's cathode during shock. The spread lens in the searchlight was adjusted during the vibration tests. This is discussed later (Section 6.7) and some effect is noted in the Post-Vibration beam data (Figure 4).

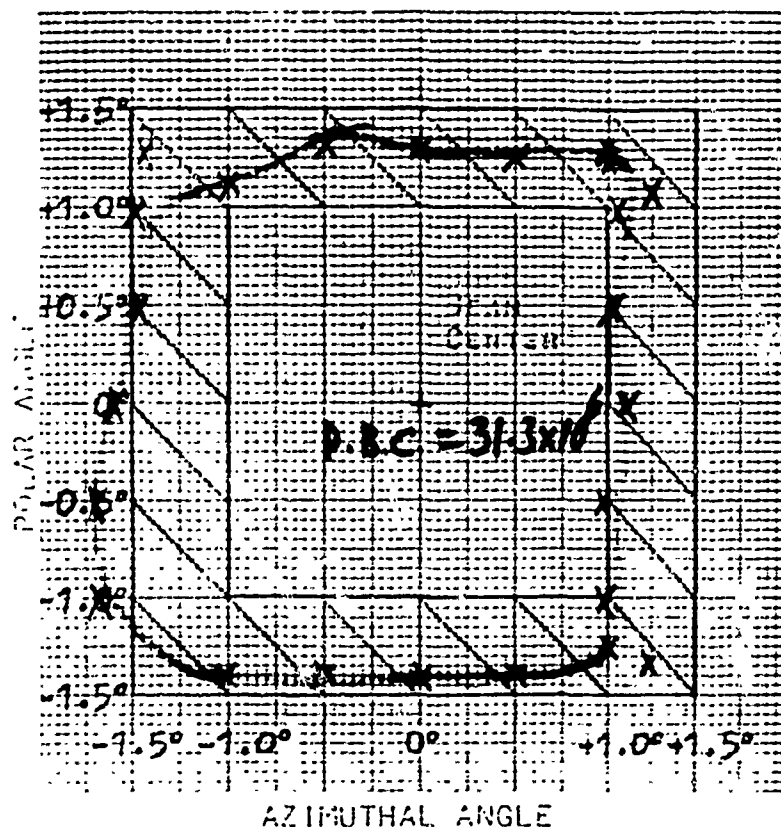
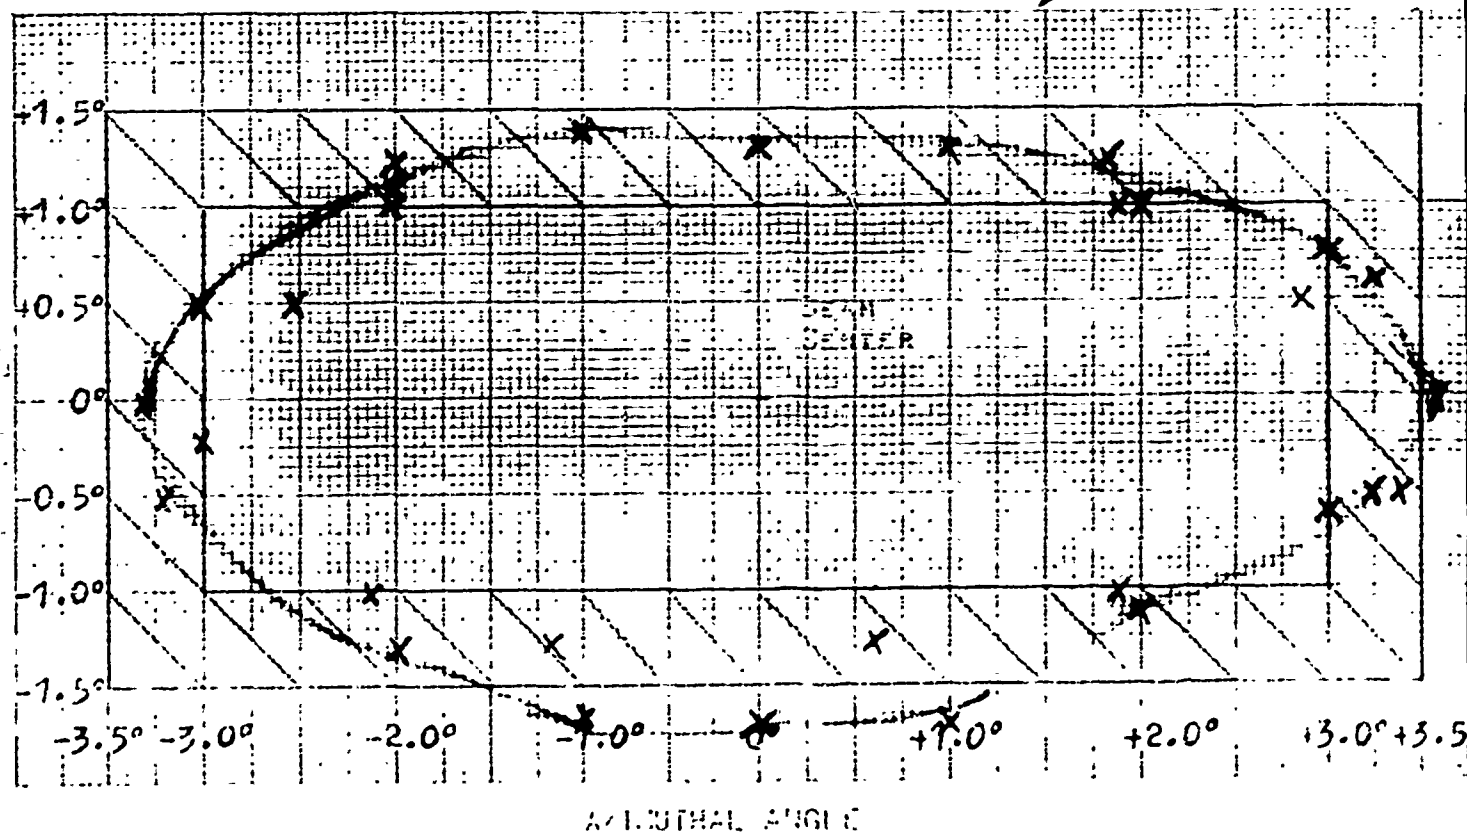
FIGURE 5

14. FEB '77  
ARC LAMP 7E175

ACCEPTABLE ZONES FOR EDGE  
OF BEAM PATTERN FOR COMPACT  
BEAM MODE AND SPREAD BEAM MODE  
(LOCUS OF POINTS AT 2% OF PEAK  
BEAM INTENSITY SHALL FALL WITHIN  
CROSS-HATCHED AREA)

SPREAD BEAM MODE

Lamp A7E172 physically survived all of the environmental tests. During a post-test ignition sequence the arc lamp became a "leaker" and lost its xenon gas. Because of this, Post-Quality Assurance beam tests could not be conducted. A second lamp (A7E175) was installed in the searchlight and beam data were recorded (Figure 5). Although this beam data, too, is not totally within the specified requirements, it does show that the EIMAC searchlight's lens system is capable of surviving all of the imposed environmental tests.

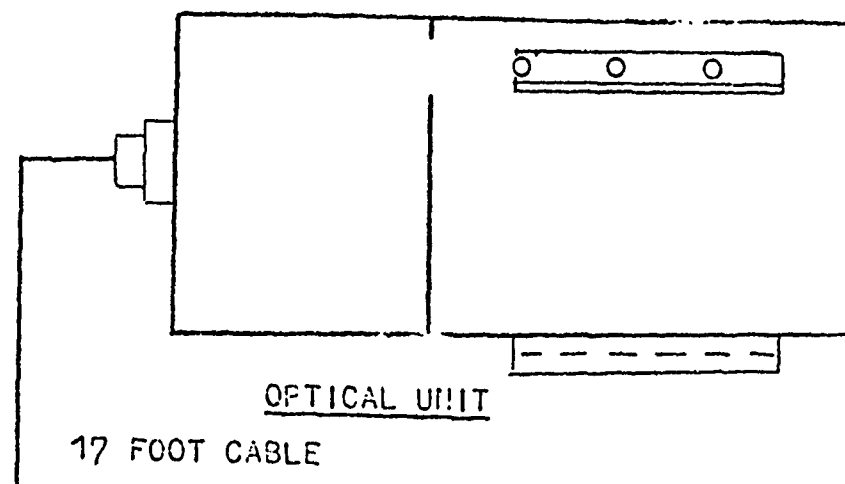
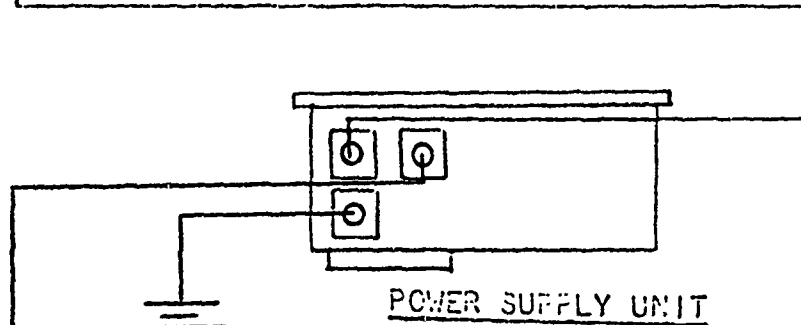
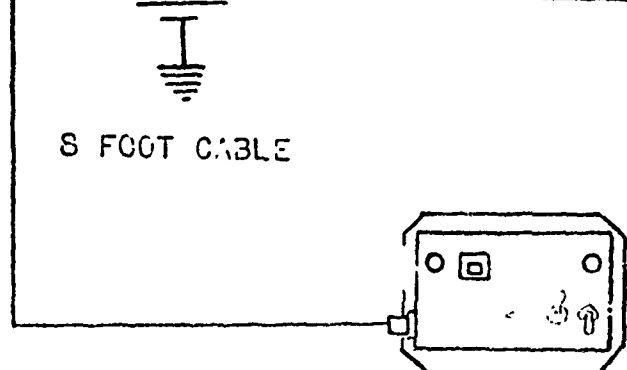
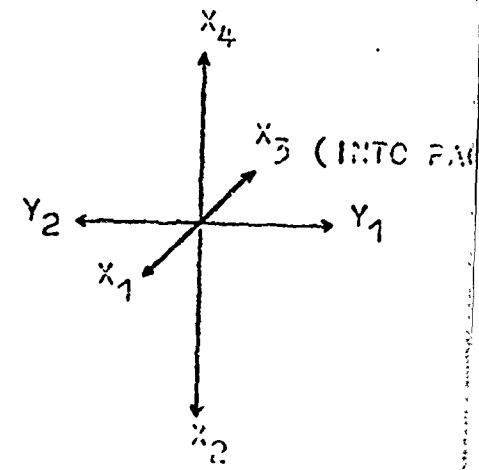
FIGURE 22  
-39-

DIRECTION	UNIT		
	OPTICAL	POWER SUPPLY	CONTROL BOX
VERTICAL	X2-X4	X2-X4	X2-X4
LATERAL	X1-X3	X1-X3	X1-X3
LONGITUDINAL	Y1-Y2	Y1-Y2	Y1-Y2

REMOTE CONTROL BOX UNIT

SEARCHLIGHT SET  
(COORDINATE AXES)

Drop No.	Direction Of Shock (See Fig. 22)	Recorded "g"	$\frac{1}{2}$ Sine Duration (Msec)	Arc Lamp S/N	All Systems Operational Following Shock	Remarks
1	X4	460	1	A7E172	Yes	Lamp extinguished, stinger stuck to cathode following attempt to relight. Removed lamp A7E172 and put in A7E175.
2	X4	465	1	A7E175	Yes	Lamp blinked but stayed ON. Fan quit. Opened searchlight and found fan DC/AC inverter moved slightly, shorted to chassis. Replaced with new inverter, System now ok.
3	X4	40	18	A7E175	Yes	Again the extinguished and the stinger stuck to the cathode during relight attempt (The second lamp to do so). Both lamps returned to EIMAC. Stingers were freed by putting AC signal into starter solenoid. Put lamp A7E172 back into searchlight.
4	X4	40	18	A7E172	Yes	Lamp extinguished, but relit with manual start. Lamp not damaged.
5	X2	38	18	A73172	Yes	Lamp extinguished, but relit with manual start. Turned off intentionally, then waited two minutes before relighting. Stinger contacted cathode, then hung up. All previous information indicates that the arc lamp's stinger is a problem area. The searchlight itself can withstand shock environments.

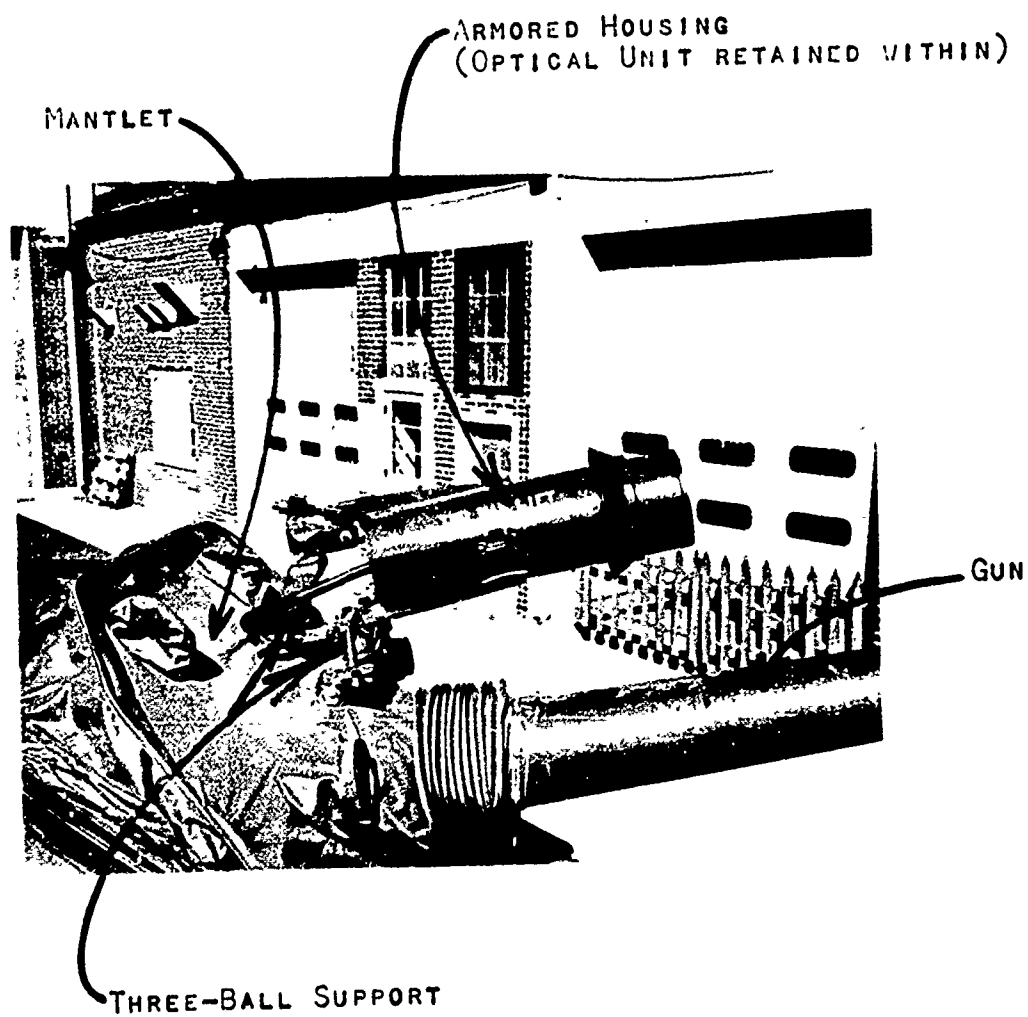
INSTALLATION OF ARMORED HOUSING ON M60A1 TANK  
FIGURE 31

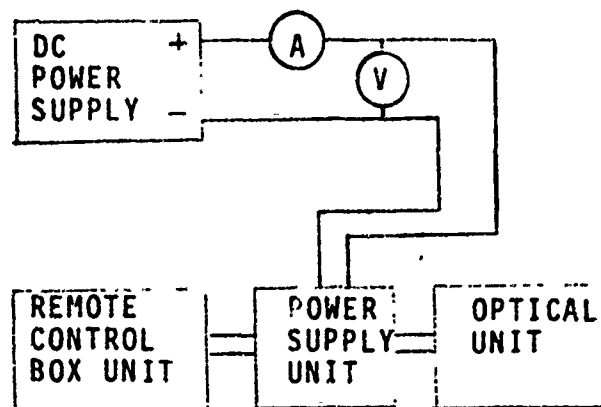
#### 4.5.1.6 TEST SETUP SCHEMATIC

- 4.5.1.7.1 Adjust the D.C. power supply to 28 Vdc and start the searchlight in the Compact, Open and Visible modes. Determine and record the time to ignite and maintain ignition. Record the searchlight current.
- 4.5.1.7.2 After the illuminator is ON, switch from the Open mode to the Blackout mode and then back to the Open mode. Record the time to change light modes.
- 4.5.1.7.3 Return the searchlight to the Open mode, switch from the Compact beam mode to the Spread beam mode and then back to the Compact beam mode. Record the time to change beam modes.
- 4.5.1.7.4 Return the searchlight to the Compact mode, switch from the Visible to the I.R. mode and then back to the Visible mode. Record the time to change beam modes.
- 4.5.1.7.5 Repeat 4.5.1.7.1 through 4.5.1.7.4, but readjust D.C. power to 24 Vdc.
- 4.5.1.7.6 Record all data.

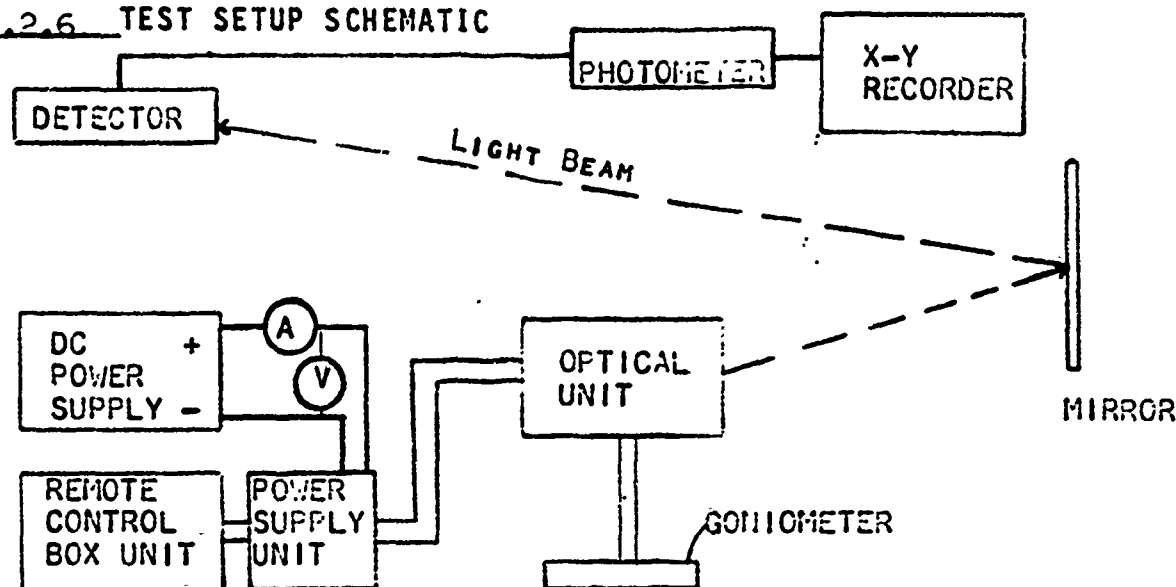
#### 4.5.2.6 TEST SETUP SCHEMATIC

**Note:** Measure the peak beam chandlepower in the following test procedure with a photometer corrected to have a response within plus or minus 5% of the Standard International Commission on Illumination Curve for photopic vision of the human eye. The photometer shall be calibrated monthly to relate meter readings to footcandles by comparison with the illuminance of footcandles of a standard lamp operating at a color temperature of  $2870^{\circ}\text{K} \pm 50^{\circ}\text{K}$ .

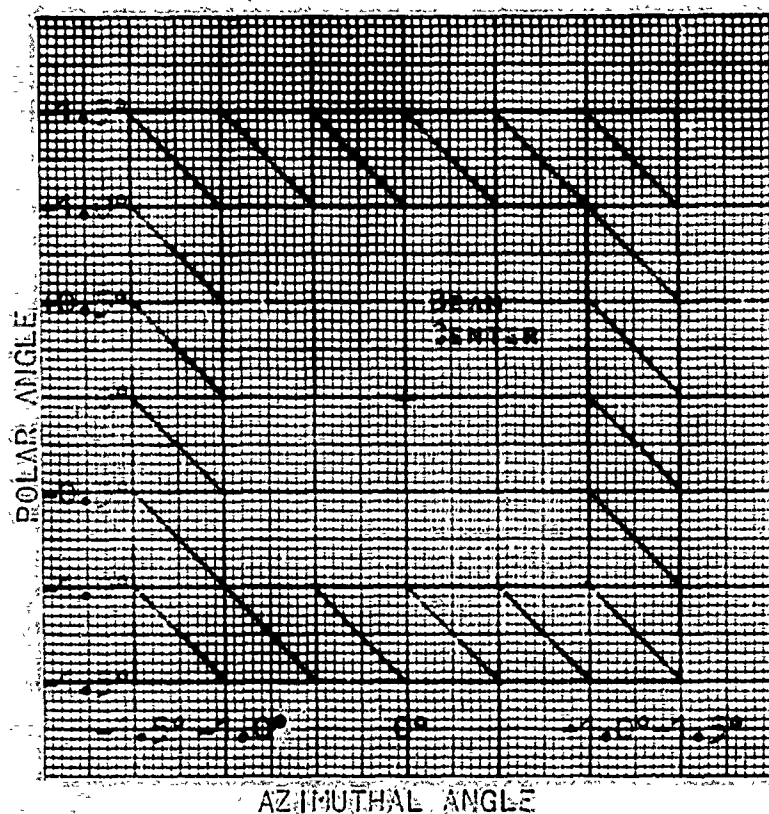
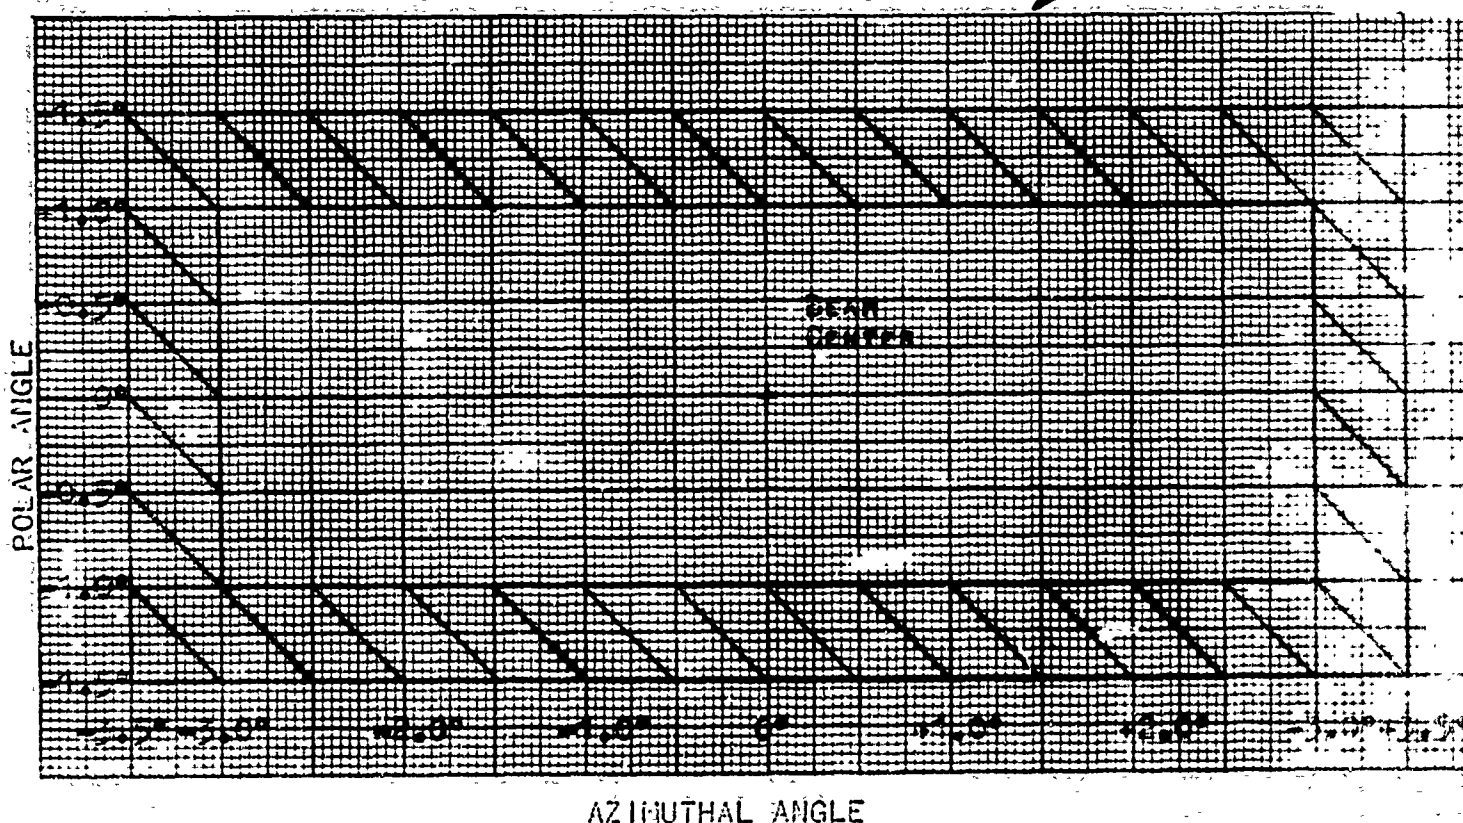
FIGURE 5

ACCEPTABLE ZONES FOR EDGE  
OF BEAM PATTERN FOR CONTACT  
BEAM MODE AND SPREAD BEAM MODE  
(LOCUS OF POINTS AT 2% OF PEAK  
BEAM INTENSITY SHALL FALL WITHIN  
CROSS-HATCHED AREA.)

CONTACT BEAM MODE

SPREAD BEAM MODE

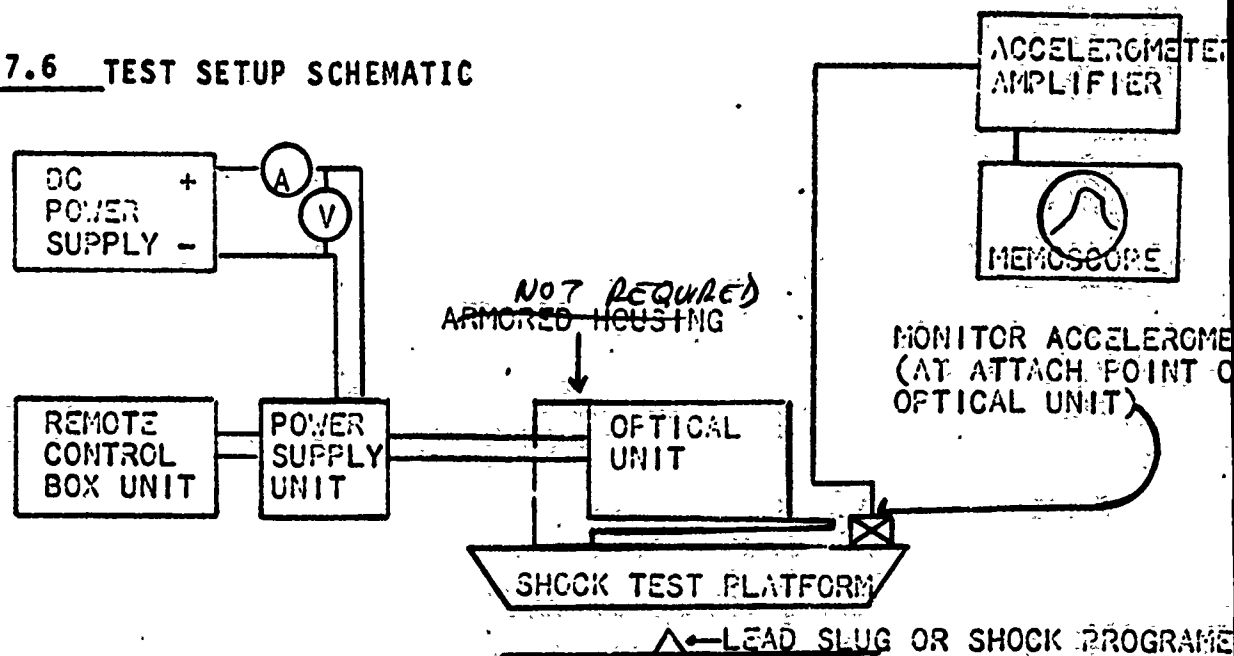
#### 4.5.7.6 TEST SETUP SCHEMATIC

- 4.5.7.7.1 Mount the optical unit of the searchlight in the armored housing. Mount the armored housing for shock input in  $X_4$  axis. (See Figure 6).

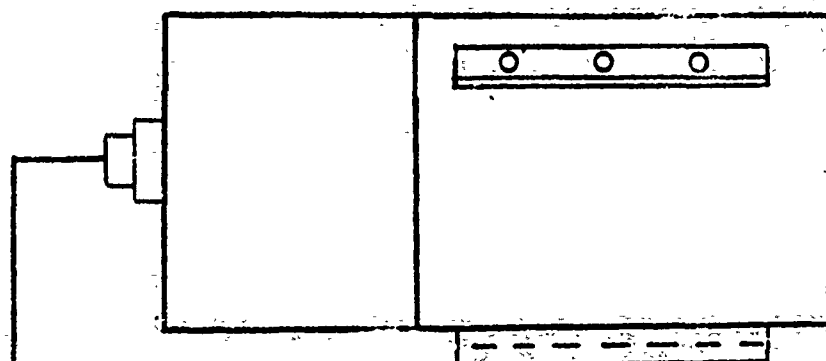
FIGURE 6

DIRECTION	UNIT		
	OPTICAL	POWER SUPPLY	CONTROL BOX
VERTICAL	X2-X4	X2-X4	X2-X4
LATERAL	X1-X3	X1-X3	X1-X3
LONGITUDINAL	Y1-Y2	Y1-Y2	Y1-Y2

OPTICAL UNIT

17 FOOT CABLE

- 4.5.8.7.1 Mount the optical unit of the searchlight in the armored housing. Mount the armored housing for vibration in Y<sub>1</sub>-Y<sub>2</sub> direction (See Figure 6).

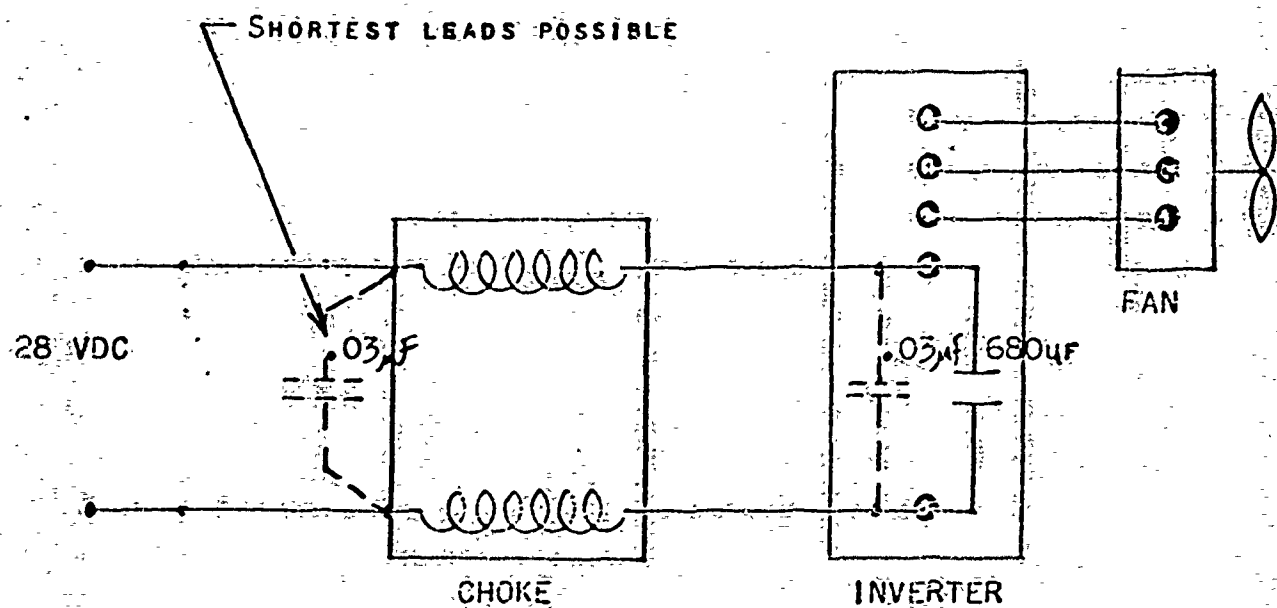
FIGURE A

NOTE: THE TWO  $.03\mu F$  CAPACITORS WERE NOT INCLUDED IN THE ORIGINAL SEARCHLIGHT'S INVERTER CIRCUIT.

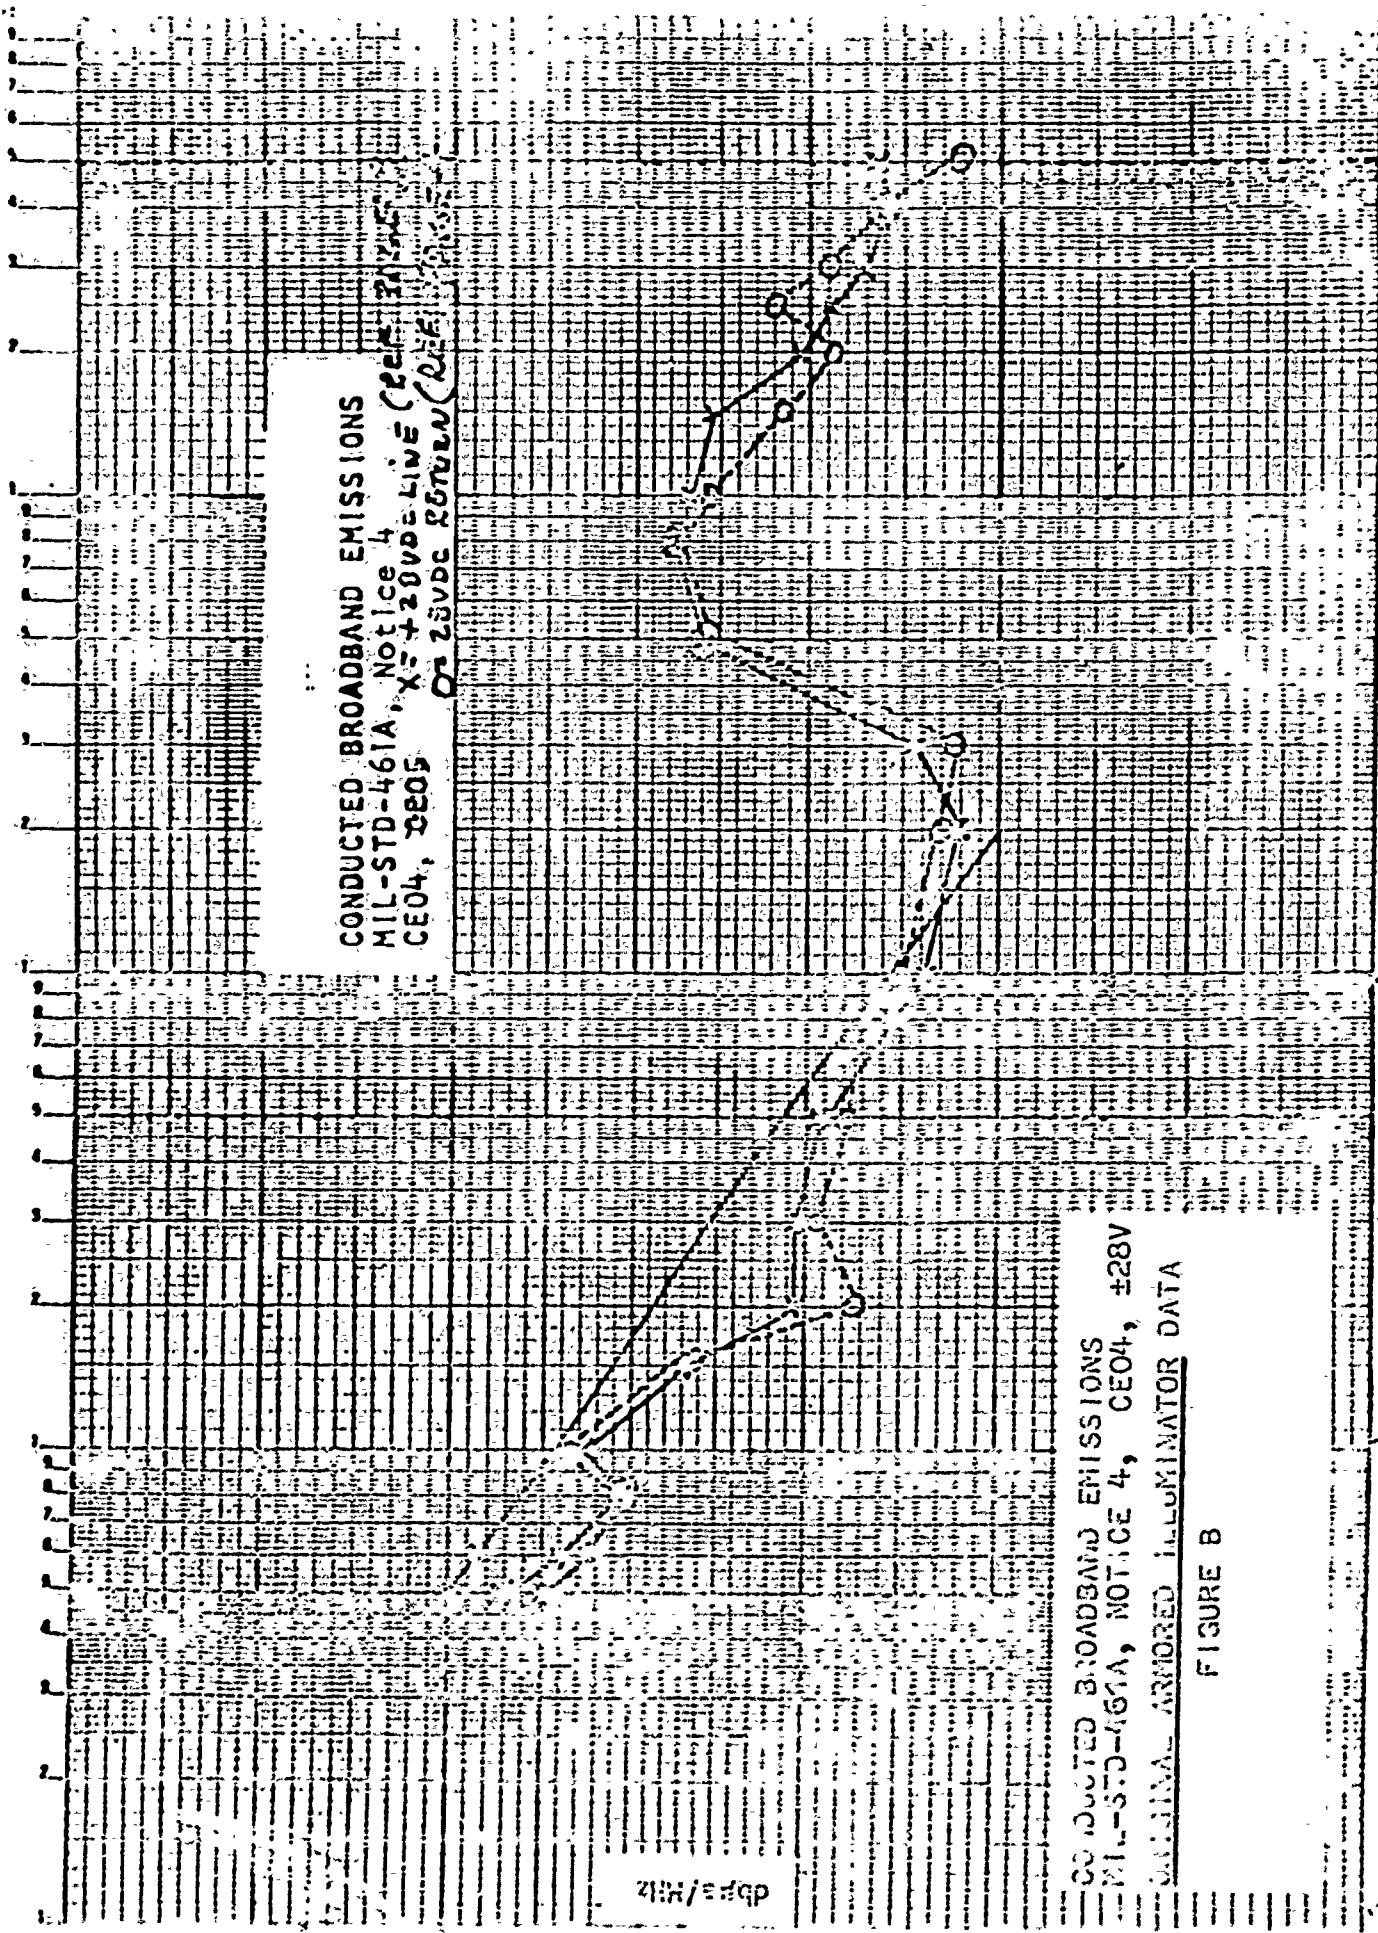
FIGURE B

CONDUCTED BROADBAND EMISSIONS  
MIL-STD-461A, NOTICE 4, CE04, ±28V  
ORIGINAL ARMORED ILLUMINATOR DATA
